**PermeNewal™ Permeation
Repair Process**

**Report of
In Situ Structural Rehabilitation of
Deteriorated Platform Concrete
Washington Metropolitan Area
Transit Authority With Vacuum**

Maryland - Washington, DC

UNIQUE REHABILITATION AND RETROFIT PROCEDURES FOR RAIL-TRANSIT STRUCTURES

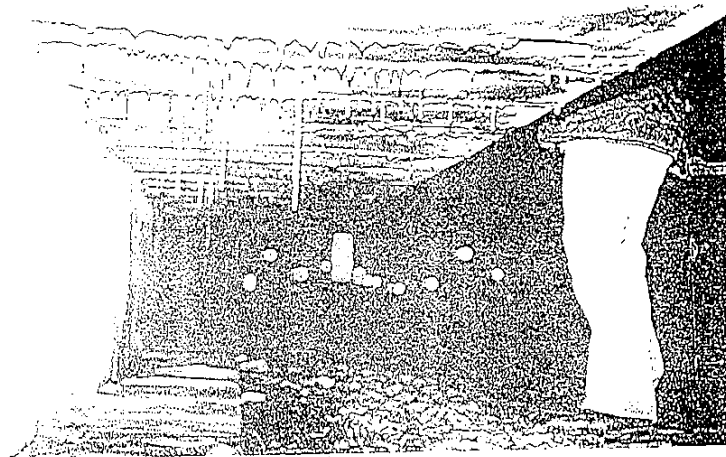
FIG.11

During 1985, when a platform paver tile rehabilitation project involving several above-ground stations was being contemplated, it was discovered that several at-grade and aerial platforms exhibited deterioration of their structural slabs, in addition to the relatively more familiar paver tile, granite edge and setting bed distress (Fig. 11).

By far the most advanced deterioration was observed in the exposed areas of the Minnesota Avenue Station platform, located on the Orange Line. Using this structure

An investigation was performed to determine the cause or causes of the deterioration. Concrete coring was performed for testing purposes. In some instances the Minnesota Avenue structural slab had deteriorated to such an extent that the core recovery with sufficiently long pieces for compressive testing was not possible. It was found that at some locations concrete strength had significantly degraded from the design value. In addition to the deterioration of the interior regions of platforms, the longitudinal edges of structural slabs and the underside of the overhangs also exhibited excessive deterioration. The concrete cores were analyzed at Construction Technology Laboratories (CTL). The petrographic examination performed revealed that among other things alkali aggregate reaction (AAR) was at work. The reaction was initiated by penetrating moisture. It caused expansion of susceptible coarse aggregates and their consequent microcracking. The expansive cracks radiated from the aggregate into the cement paste degrading the concrete microstructure and hence its strengths.

It was evident, that the platform concrete was exposed to very aggressive environment. During the winter, rainwater and snowmelt combined with deicing salts infiltrated the cement-grout setting bed, through the paver tile joints and through any cracks in the tiles, and through expansion joints. In addition to AAR, the moisture intrusion caused the setting bed and the concrete slab to deteriorate from freeze-thaw cycles. The testing also revealed freeze-thaw damage to the structural slab as well as the setting bed. Less than optimum air entrainment had promoted the freeze-thaw damage. Chloride contamination, from deicing salts, also contributed to some rebar corrosion.

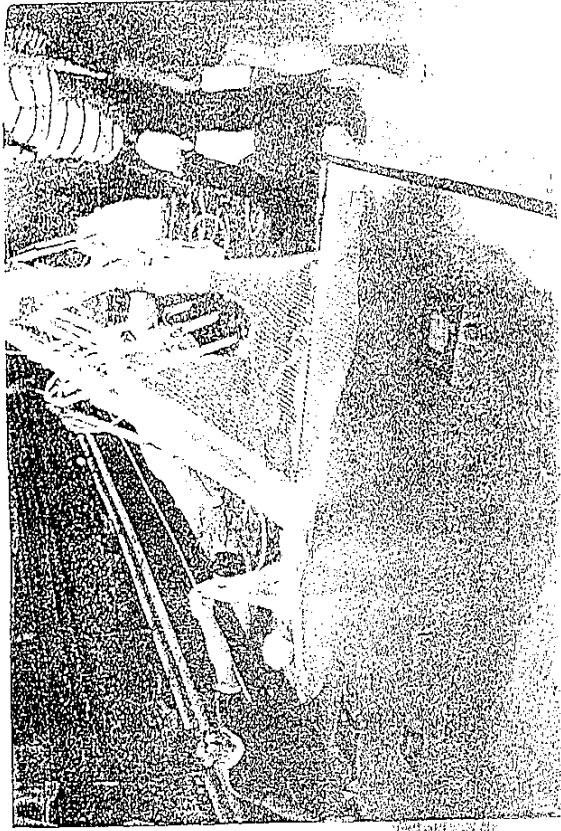
FIG.13

A 170-square foot area of deteriorated slab at Minnesota Avenue Station was selected to perform the trial retrofit. The trial was concluded in July 1985 (Figs. 12 thru 15). Low viscosity methyl methacrylate (MMA) resin was used to impregnate concrete and to seal the cracks. MMA was chosen because of its low viscosity, high strength, flexibility, and good bonding and wetting properties. MMA is not temperature sensitive and can be relatively easily mixed or modified. Additionally, fresh MMA can be easily bonded to the previously set MMA.
