Connecticut DOT Repairs I-84 Pier Cap

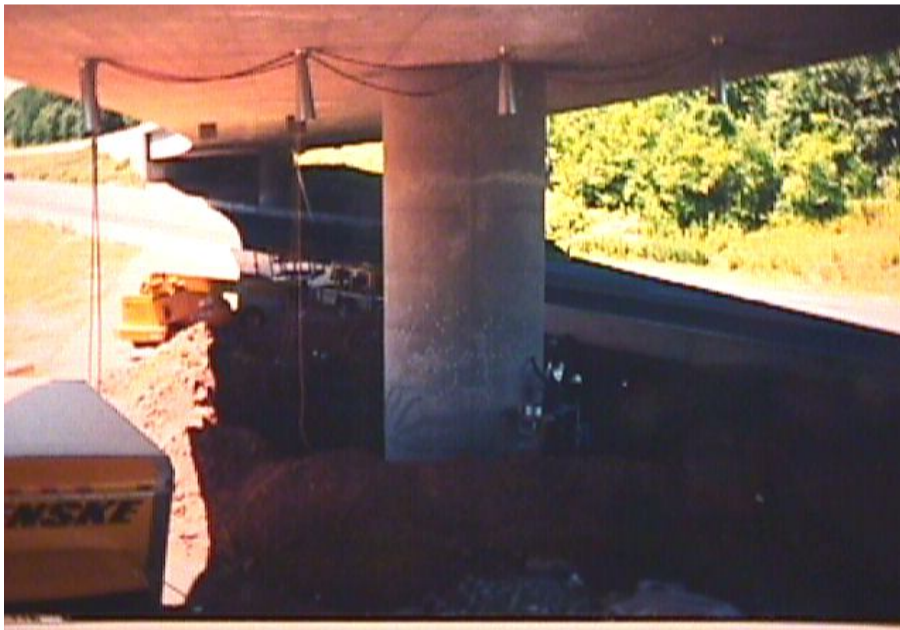
After detecting serious cracking on a number of I-84 pier caps the Connecticut Department of Transportation sought a means of completely filling the fractures and voids.

The massive pier caps were eight feet high, thirty five feet wide and fourteen feet thick connecting five cells of the structure.

Observation inside the cells revealed the failure of previous pressure injection efforts.

It was confirmed with Connecticut DOT that the previous injection of the cracks was at best marginal with penetration depths ranging from 1/4" to 6".

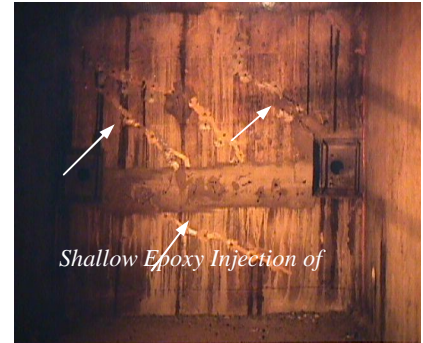
Final preparation of the vacuum injection of the pier caps was begun. This preparation included the continuity audit of the existing cracks to determine the expected filling.

Of the five cells, two promised installation of new repair materials across the entire 14' thickness of the cap.

Upon beginning the injection of the first cell, the extent of the void areas began to develop. The first cell to be injected took in excess of 60 gallons of the low viscosity repair resin before reaching refusal.

Technicians drilled behind the unsuccessful pressure injection and intersected the fracture zone.

The existing epoxy seal, that had been left in place was inspected and all unbonded lengths were sealed. A special methodology of testing the length and extent of the cracking was employed on each individual crack in the pier cap prior to beginning the injection.

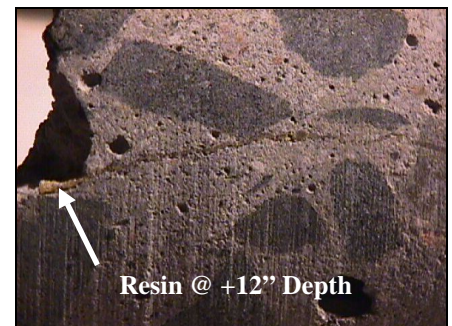
In all, the single pier cap was permeated with some 200 gallons of repair resins. In one of the cells, technicians successfully pulled resins through the entire thickness of the cap, some 14'.

Despite the surprising condition,

previous failed attempts, confined space restraints and complicated access coordination this was a difficult job well done.
