Vacuum Technology Report

“ACCURATE INVESTIGATION GUIDES THE PROPER REPAIR”

Topping is rebonded by vacuum

Connecticut DOT Repairs I-84 Pier Cap

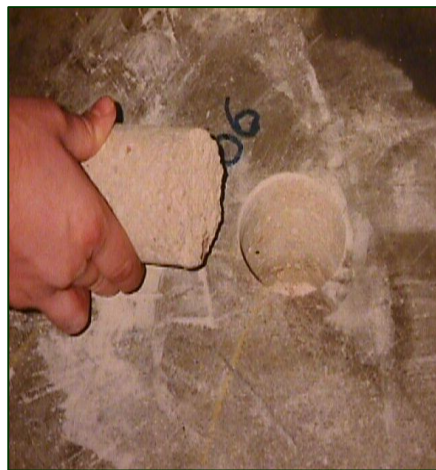
Core examination of rebonded topping slab

The “T” panel supporting panels were not closely constructed. In preparation, spaces between the panels were sealed and backed to retain the repair resins. Each delaminated area was drilled to access the debonded zone and porting devices were mounted to the surface and capped. Vacuum was applied to the delaminated areas and an acrylic polymer (methyl methacrylate) was installed to reestablish composite bond. Upon completion, the entire area was load tested to assure success and future performance.

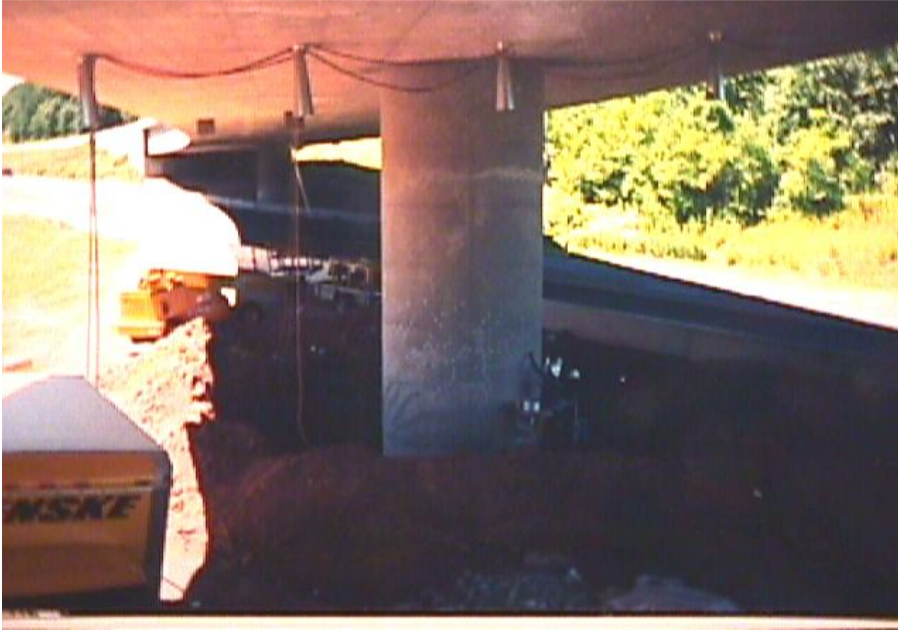
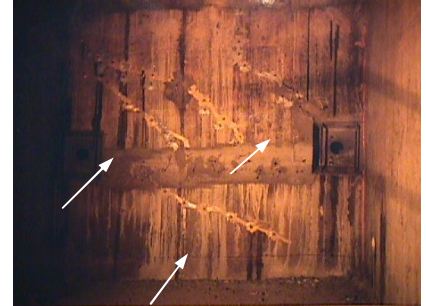
Technicians drilled behind the unsuccessful pressure injection and intersected the fracture zone.

Observation inside the cells revealed the failure of previous pressure injection efforts.

It was confirmed with Connecticut DOT that the previous injection of the cracks was at best marginal with penetration depths ranging from 1/4" to 6".

In all, the single pier cap was permeated with some 200 gallons of repair resins. In one of the cells, technicians successfully pulled resins through the entire thickness of the cap, some 14'.

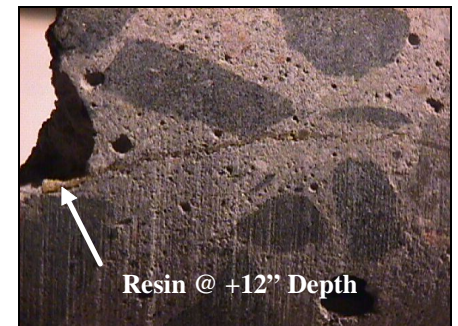
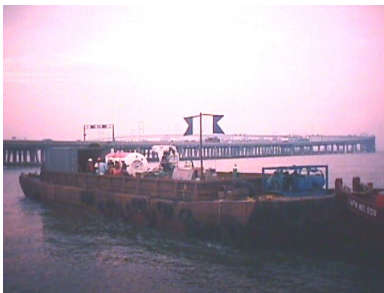
After cleaning the face of the mammoth pier, a host of unscheduled cracks and voids were measured and documented. "Some of the cracks are huge and there is one void big enough to drive a car into." Says SMS dive technician supervisor James Michel. .

Indeed, a void in the support footing of the pier measures out at 35' wide, 19' deep and 7'-8' high. Technicians intend to begin filling the void upon their arrival in April 98'.

Additionally, diving repair technicians intend to employ TECVAC's™ proprietary method of underwater crack injection destined to revolutionize the underwater crack repair market.
