## Tecvac Makes Problems Go Away - Bug Holes

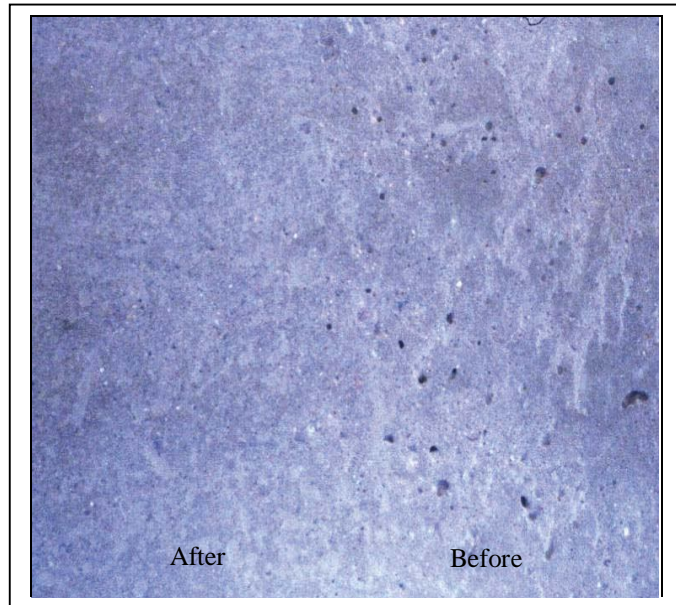
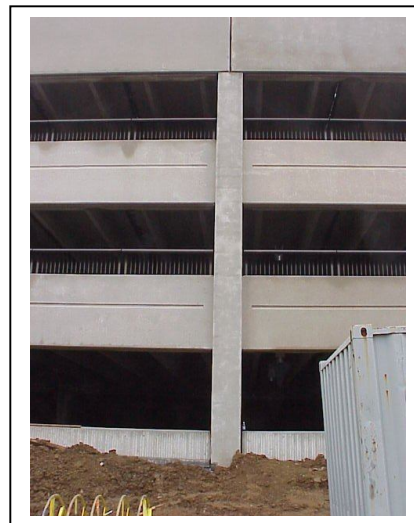
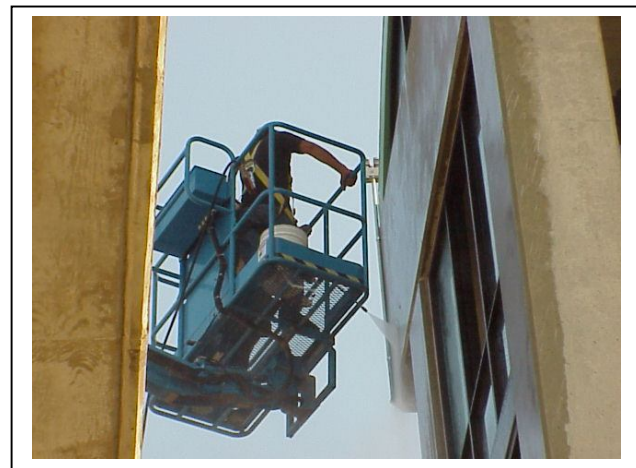
- Precast column members displayed severe "bug holes" in the delivered product.
- Numerous attempts by others could not achieve acceptable finish.
- If the desired finish could not be achieved, the member would be rejected.

- The failed materials were removed from the members
- Polymer modified grout was colored to match the member
- The member was prepared and scrubbed with the color matching repair material and allowed to cure.
- High pressure water was applied to the repaired area and examined for damage and scour.
