## Union Station Link Ramp Structure - Washington, DC

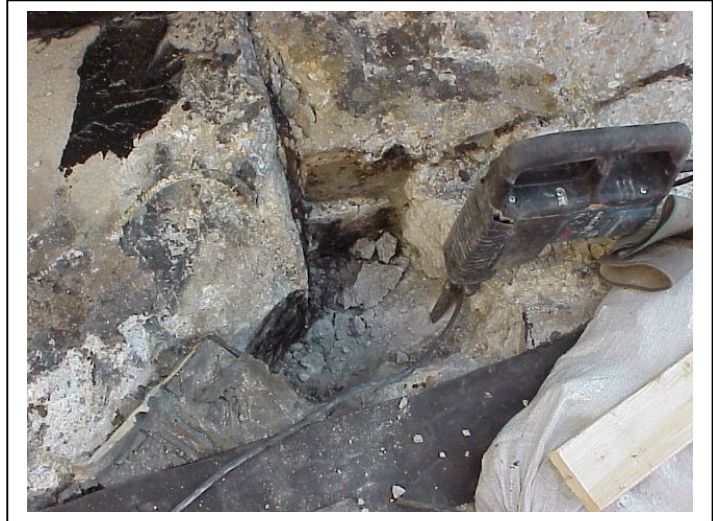
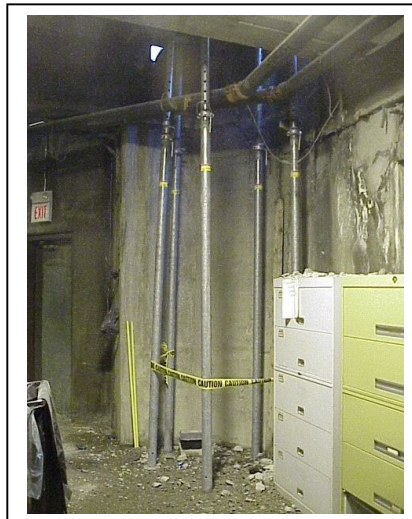
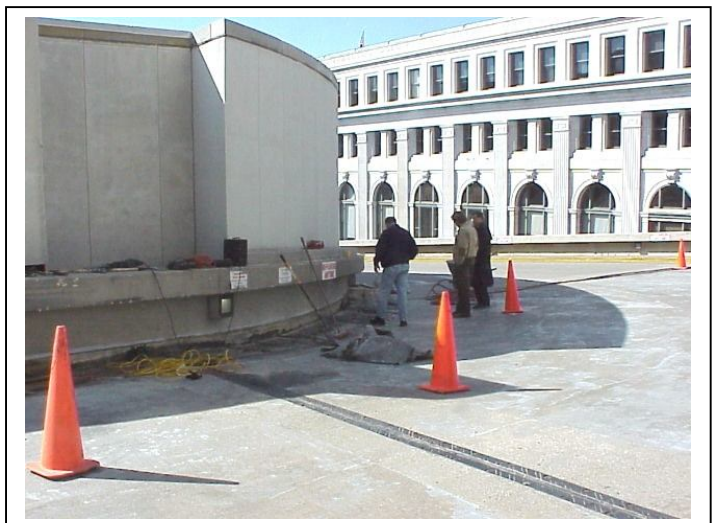
- Severe and chronic leakage into the facility through cracks and expansion joint assemblies.
- Deteriorated concrete
- Broken prestressed tendons
- Operations cannot be interrupted

- Removal of the walkway
- Design and rehabilitation of the expansion joint assembly
- Shoring
- Removal and replacement of deteriorated beam/column concrete.
- Vacuum structural repairs with PermeJect™ Permeation Injection Process
- Temporary signage and graphics for traffic routing to accommodate the work.
