**PermeNewal™ Permeation
Repair Process**

**Report of
In Situ Structural Rehabilitation of
Deteriorated Platform Concrete
Washington Metropolitan Area
Transit Authority With Vacuum**

Maryland - Washington, DC

UNIQUE REHABILITATION AND RETROFIT PROCEDURES FOR RAIL-TRANSIT STRUCTURES

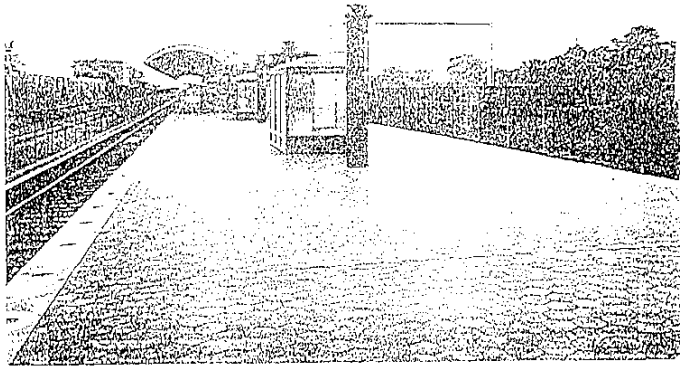
FIG.10

Passenger station platforms, and other pedestrian areas accessible to patrons, are characterized by WMATA's familiar paver tile construction. The aesthetically-pleasing tiled surfaces make a strong and unifying statement in terms of WMATA's systemwide station architecture (Fig. 10). For typical platform construction, a six to eight inch thick reinforced concrete slab, supported by walls, serves as the primary structural support system. The slab is cast-in-place using 3,500 psi concrete. Along its longitudinal edges, adjacent to the tracks, the platform slab overhangs approximately 5'- 9 1/2". Customary construction has employed three to four inch thick non-structural setting bed over the structural slab to serve as a substrate for the paver tiles. In the original construction, the tiles were installed using latex-portland cement mortar. The tile jointing material was latex-portland cement grout. The platforms are typically provided with 18 inches wide granite edging, laid on one-inch thick non-structural setting bed. The aboveground station platforms are provided with transverse expansion joints typically at 50 ft on centers.
