PermeNewal™ Process Shuts Down Capillary Action By Deeply Penetrating Cast Stone

*Cast Stone Window Ledge
Repaired With TECVAC, Inc.'s
PermeNewal™ Permeation
Injection Process Demonstrates
Ability To Restore Structural
Integrity and Shut Out Water.*

Washington, DC — TECVAC, Inc. permeated a deteriorated cast stone window ledge at the Fountain Condominiums Complex to demonstrate the ability of PermeNewal™ to restore and seal.

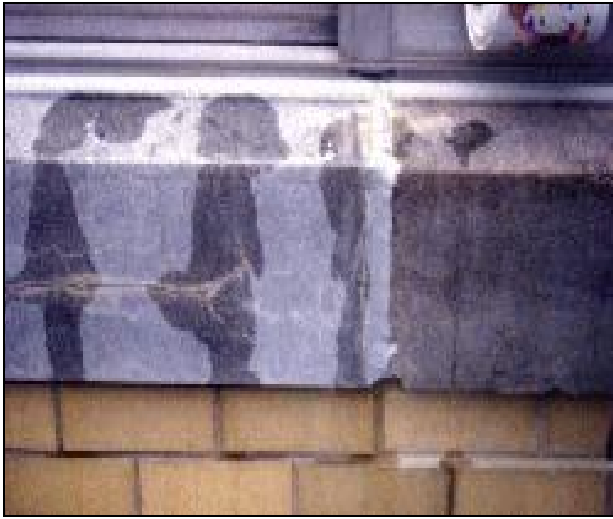
Water Rolls Off Treated Window Ledge Stone

The 8"x 8"x4' long window ledge demonstrates a convincing testimony of the ability of PermeNewal™ to permeate deep into damaged materials. In just over 10 minutes the test piece accepted a full two gallons of repair resin, affirming the porosity and vulnerability of the 30 year old material. Visual examination of a cross section revealed resin penetration to a depth of 90% of the total mass and rendered the material brick hard. Water applied to the treated stone beaded and ran off while the untreated material absorbed like a sponge.

The PermeNewal™ Permeation Injection Process is a specialty repair technique developed by Washington based TECVAC, Inc. to structurally restore large areas of deteriorated concrete, masonry and stone. The vacuum process enables the restoration of deteriorated materials that would normally require demolition and replacement. Closely aligned map cracking and similar damages can now be renewed.
