Topping Slab Is Re-bonded Using TecBond™ Interface Permeation Process

Washington, DC - Tecvac, Inc. has re-bonded a four inch topping slab that was delaminated from the structural slab.

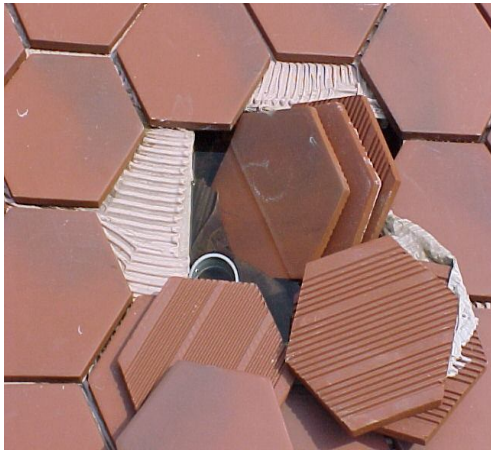
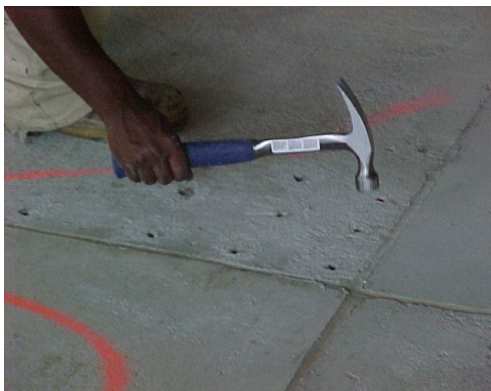
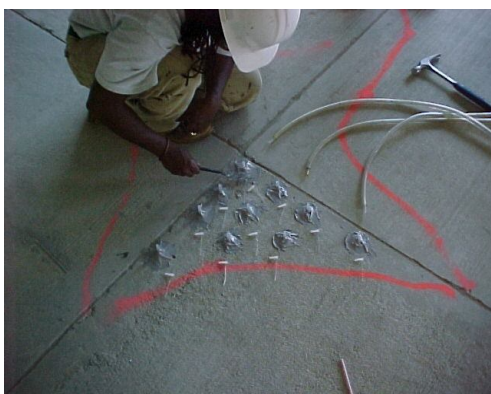
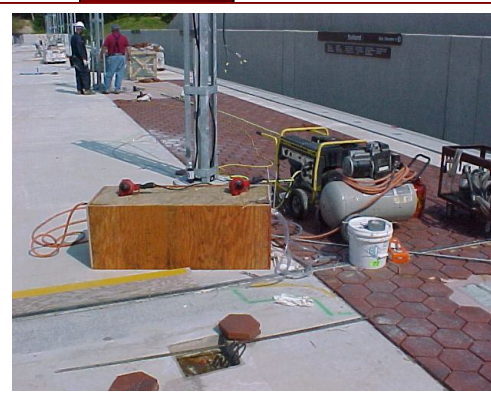
After hammer sounding the slabs to identify delaminated areas, WMATA selected three areas to perform testing. The TecBond™ Process was performed on the designated areas. Small holes were drilled through the topping slab to intersect the delamination zone. Moisture encountered within the delamination zone was extracted using Tecvac's HotBox™ Crack Dryer. Effluent air measuring 90% humidity was reduced to less than 7%. Vacuum force was applied to the dry zone and repair resin was introduced.

Independent core testing concluded that the vacuum process was a success. Each of the extracted cores broke well into the structural slab, which demonstrated that the composite nature of the bond line had been established.
